**HISTORIC BUILDING RECORDING
AT
CHAIN BRIDGE FORGE,
HIGH STREET,
SPALDING,
LINCOLNSHIRE
(SPCB11)**

The Friends of
Chain Bridge Forge

January 2011

A.P.S. Report No: **150/11**

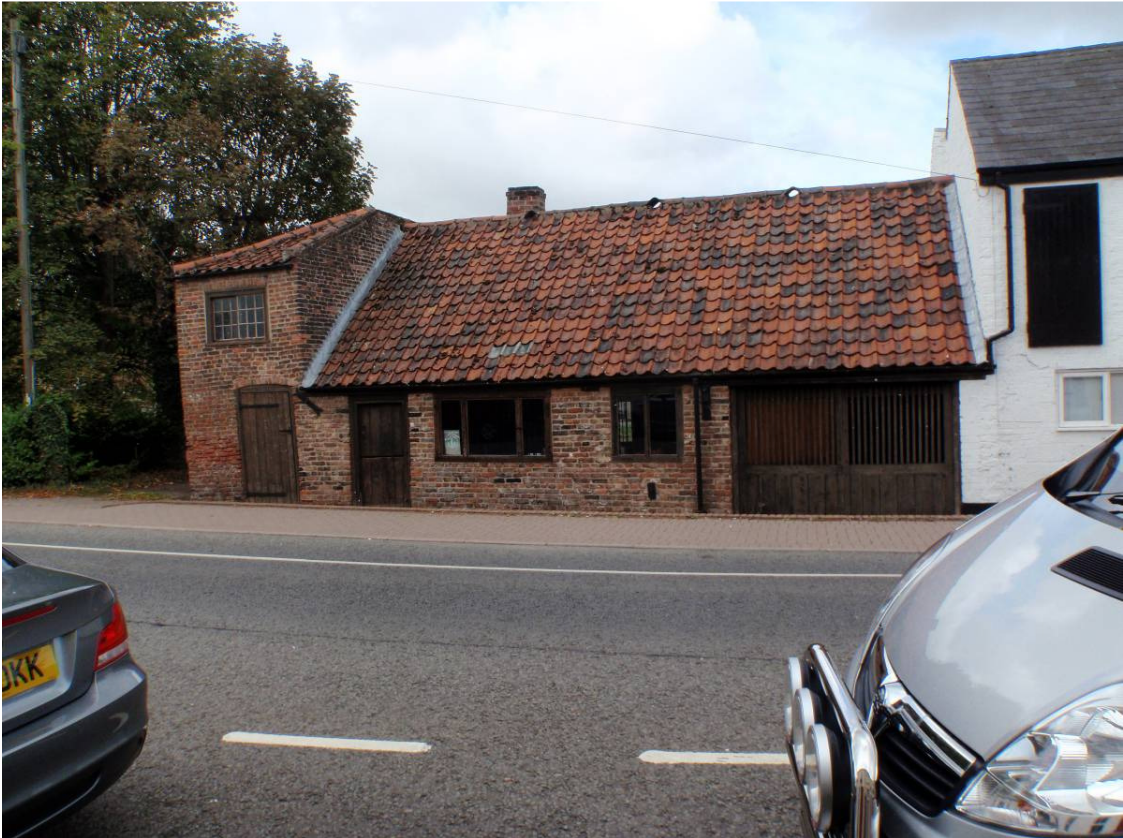
Plate 2 Eastern elevation, looking west

At ground floor level, the 2-storey block has a planked door with a segmental arch of brick rubbers (Plates 1, 2). The upper storey contains a Yorkshire sliding-sash window, topped by another segmental arch of brick rubbers. Bricks within this two-storey section of elevation have a mix of horizontal and diagonal stacking marks.

Within the single storey block, the eastern elevation contains a planked stable door at the south end and, at the northern end, double planked doors with ventilation slats in their upper half. Between the two entries are two windows, one of three lights, the other with two. Pintles protrude from the frames of these windows, with a pair on either side of the 3-light window and a single pair on the south side of the 2-light window.

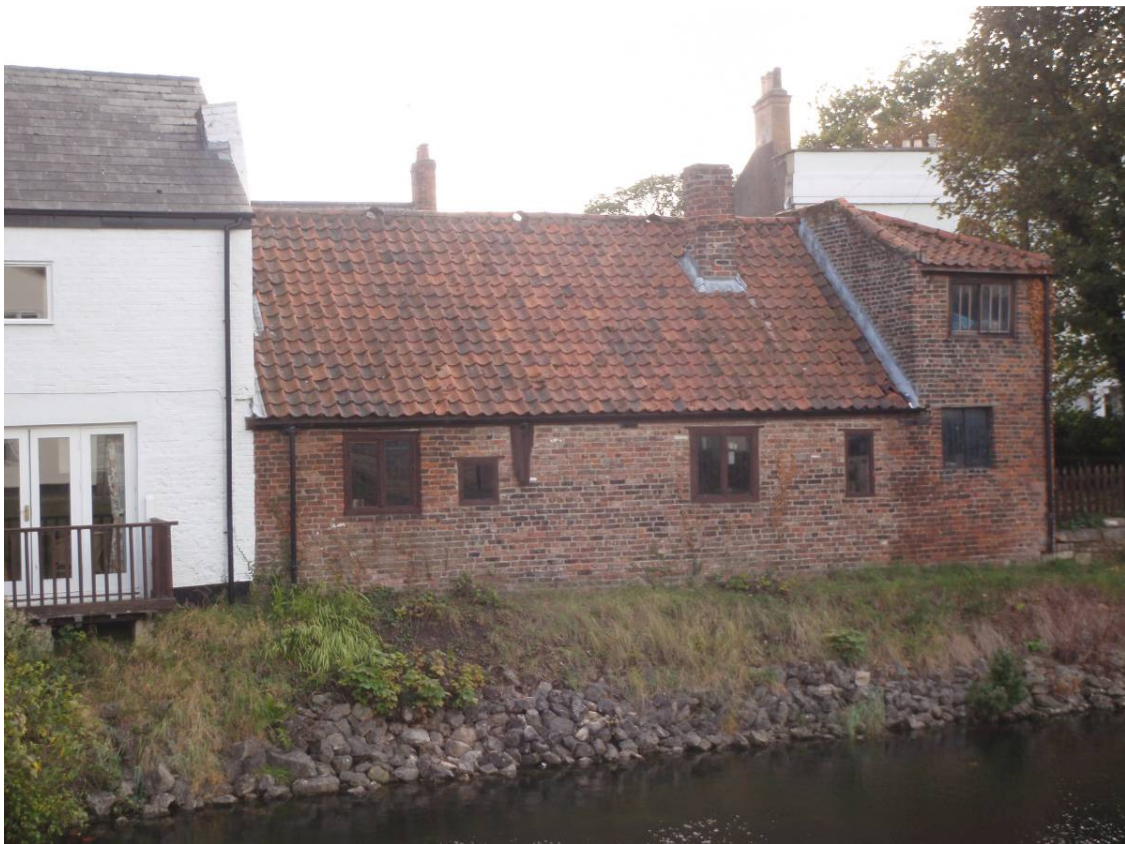
Plate 4 Western elevation, looking southeast

In the remaining, single-storey, section of the western elevation are four windows. Two of these are 2-light openings and the other two are smaller, single-light windows (Plate 4). Adjacent to the northern windows is a section of timber, held in place at the top by a bolt to a tie rod. The bricks in this elevation have a mix of horizontal and diagonal stacking marks. There is a small brick plinth at the foot of the wall. A brick chimney protrudes out of the roof on this side of the building.

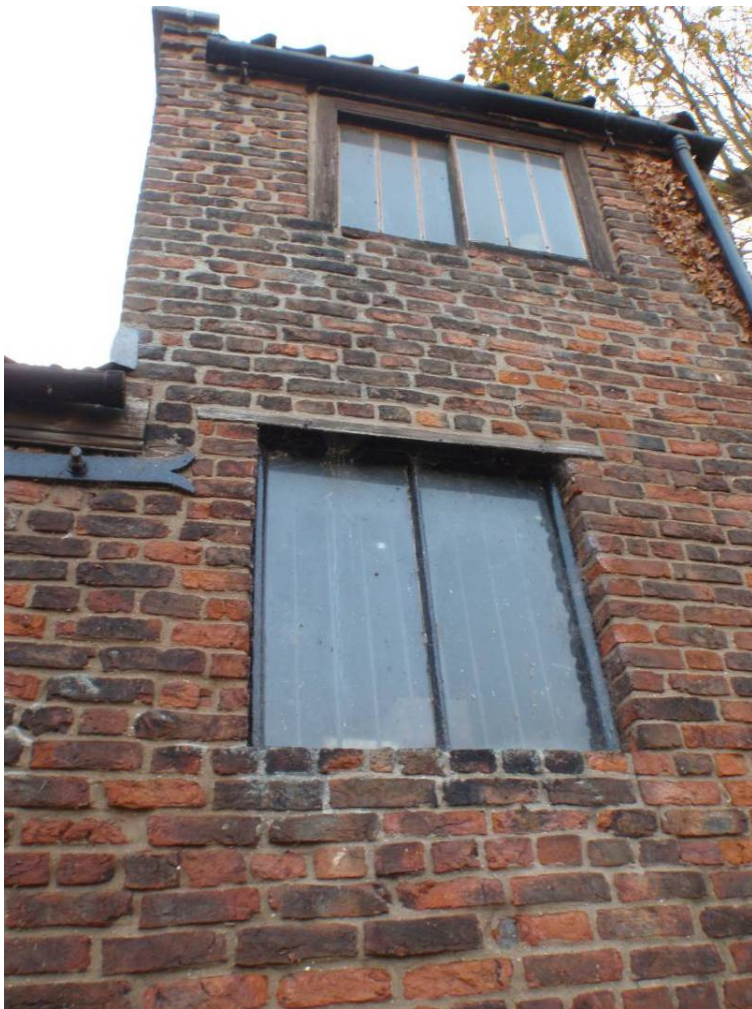
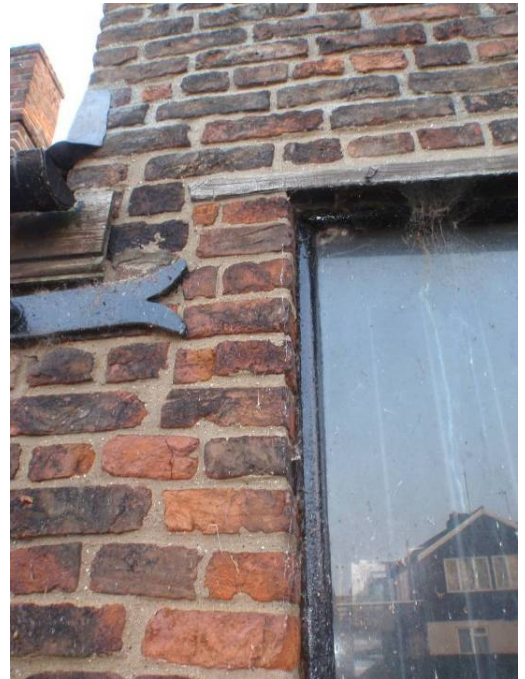
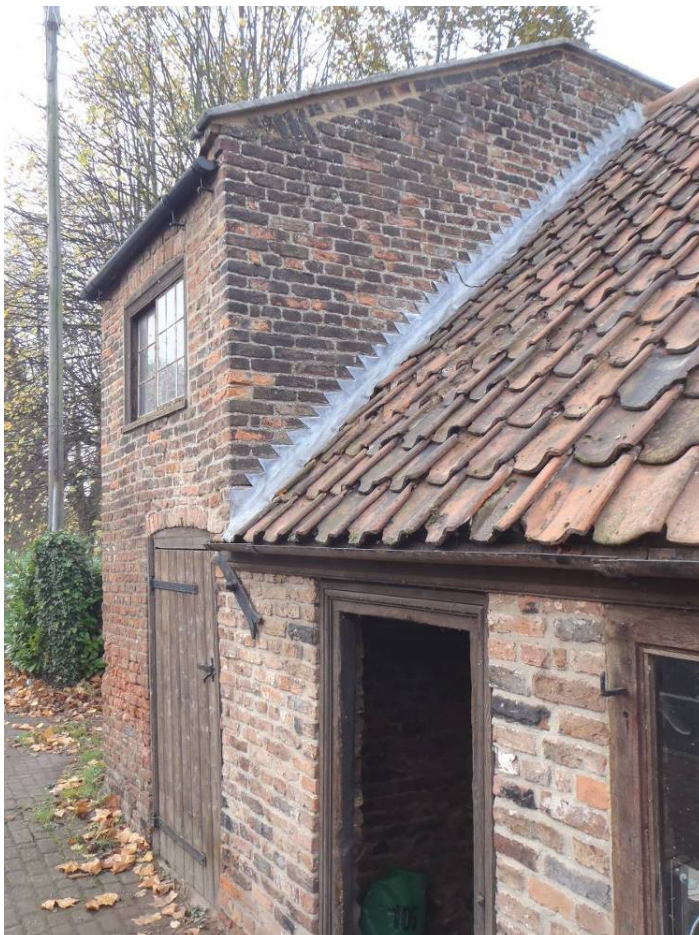
(left) Plate 5 Detailed view, western elevation of 2-storey block

than any other window in the building. There is a section of straight join from the northern end of the wooden lintel, down alongside the window. Additionally, there is also a length of header bricks, in what is otherwise a course of stretchers, directly above and restricted to the width of the window (Plates 5, 5a).

(below) Plate 5a Western elevation, detailed view of straight join by window

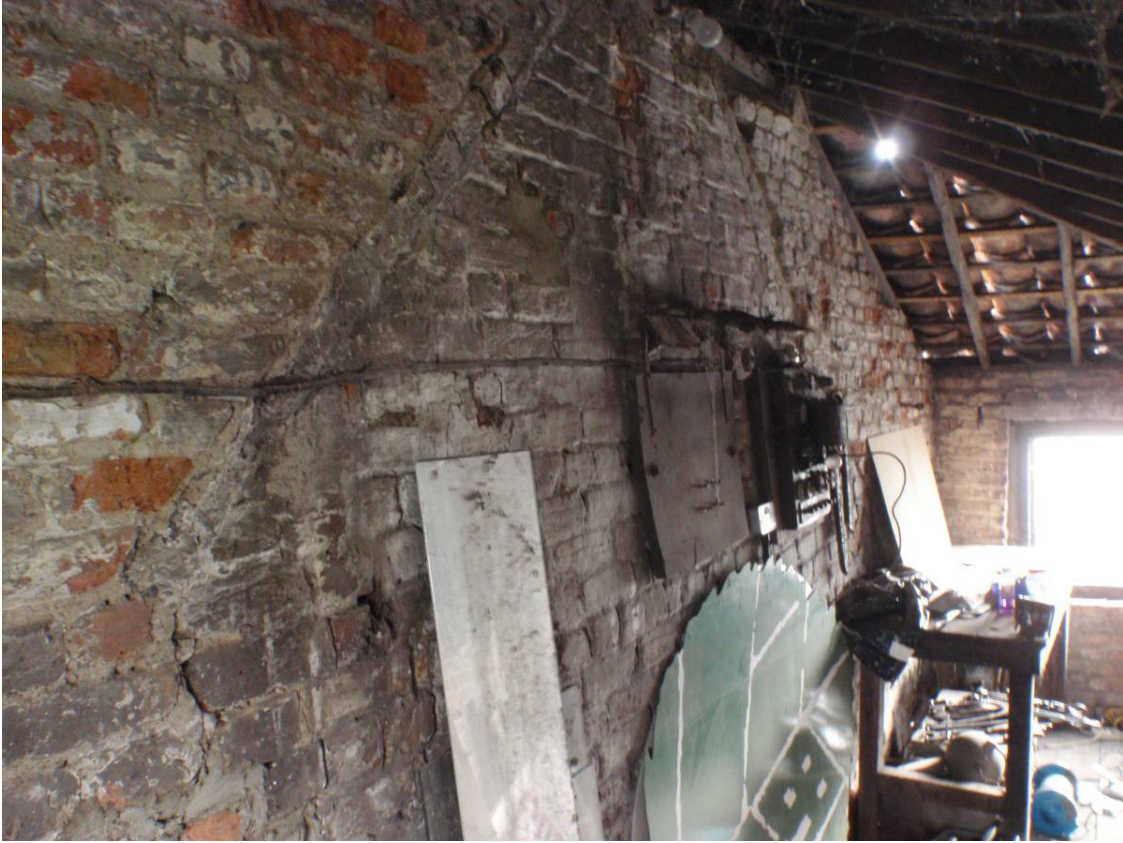
(below) Plate 8 Two-storey southern block, upper floor, looking northwest

A fixed step ladder provides access to the upper storey. In the east and west walls of the upper storey are Yorkshire sliding-sash windows (Fig. 6; Plate 8). The north wall is a trapezoidal, truncated, gable. Evident within this elevation are the pitch lines of a triangular gable (Fig. 8; Plate 9).

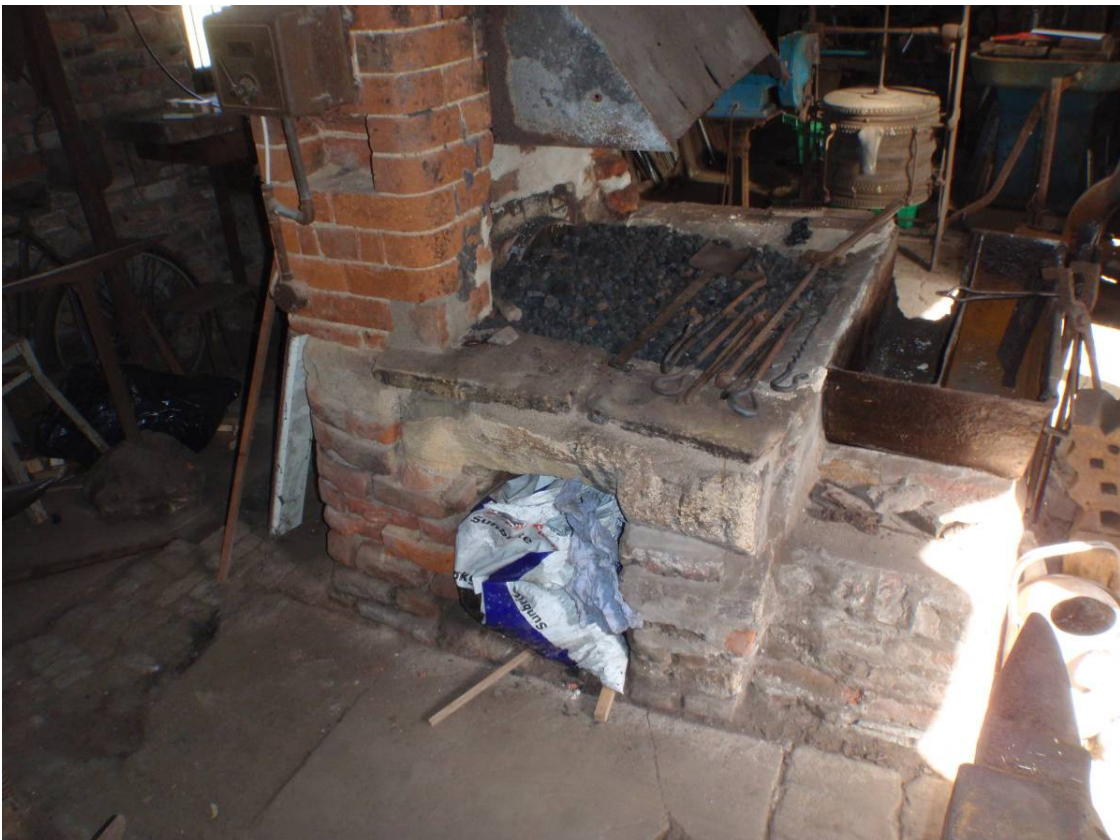
Plate 11 Detail of plinth and possible return wall, and flagging, by south wall of smithy, looking west

Most of the southern wall of the room is on a plinth. This plinth is at a slight angle to the wall above, extending out more to the north at its eastern end. The adjacent floor covering of flagstones is set parallel to this plinth, rather than the wall (Fig. 6; Plate 11). Similarly, the forge, located south of the centre of the room is set parallel with the flagstones and plinth and not square to the room. Additionally, the anvil is also set approximately parallel with the flagstones. Adjacent to, and on the south side of, the anvil base are some slightly upstanding stones, apparently a right-angled extension to the plinth by the south wall. More stonework continues immediately to the north of the anvil but is level with the ground and is worn smooth.

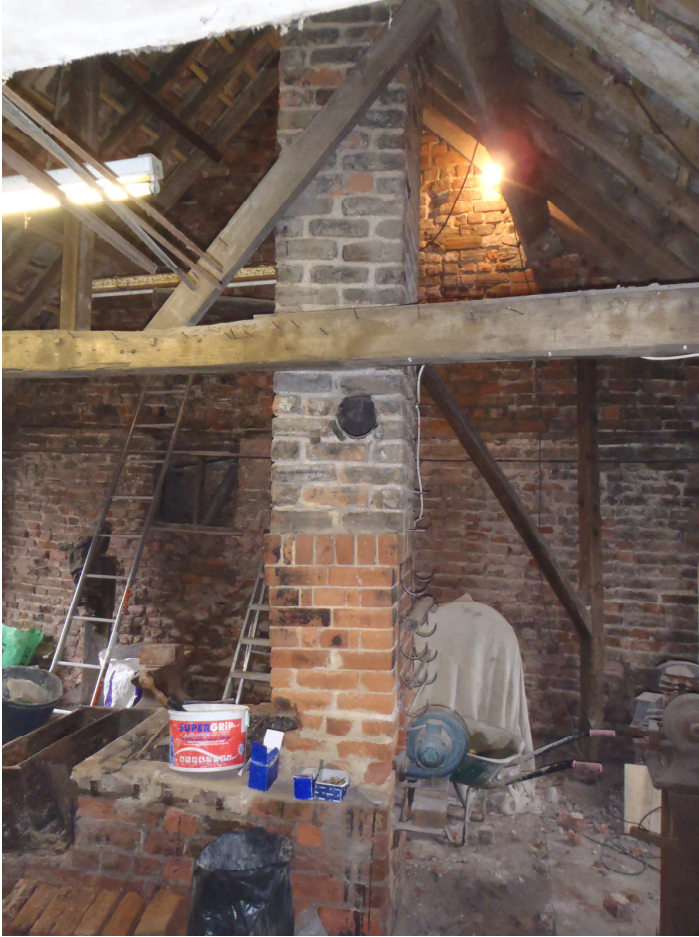
(below) Plate 12 Forge, detail, looking north

The forge is mostly of handmade brick with some pieces of stone, including a limestone block with a chamfered opening that serves as the top of the lower flue (Plate 12). The forge appears to have been extended on the front, east, side with a slightly lower and narrower platform. Constructed of handmade late 19th century brick, this platform is used to support quenching troughs. On the west side of the forge, at its northern end, is a straight join. To the north of this straight join, and providing the entire north side of the forge and extension, is walling that incorporates handmade late 19th century, brick.

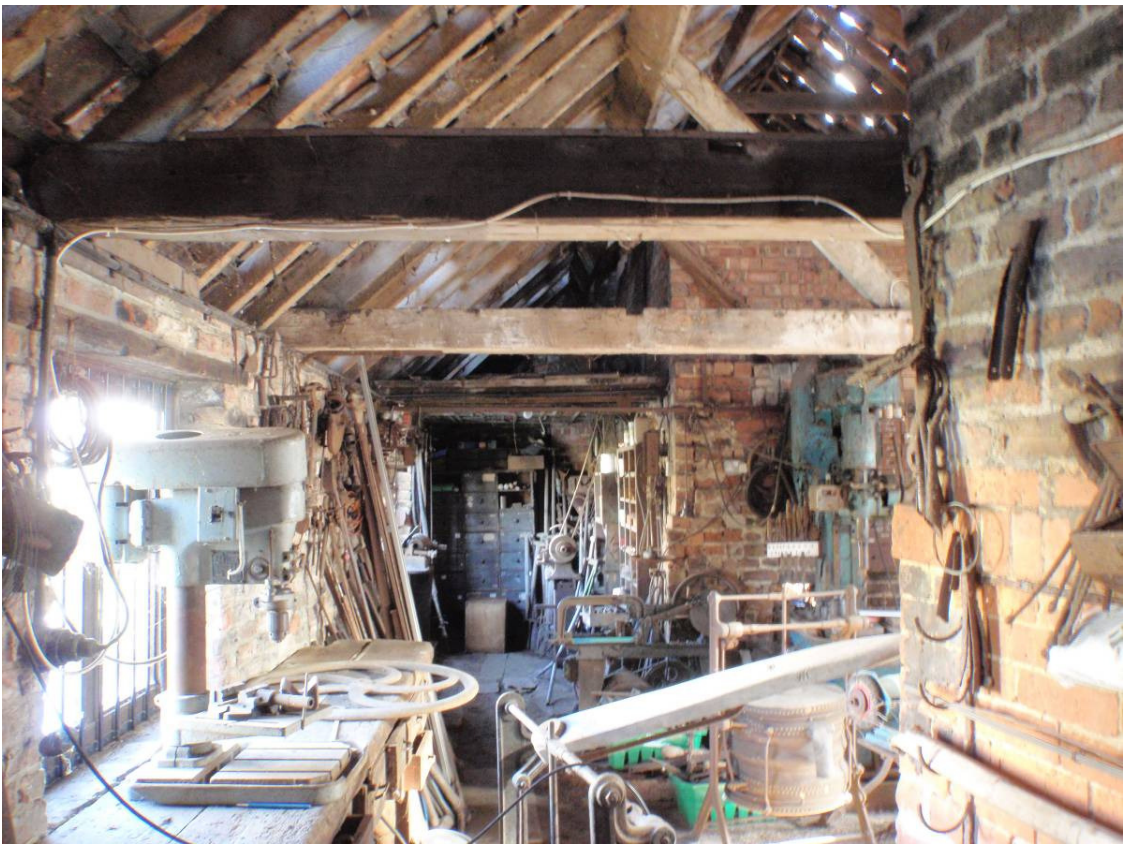
Plate 13 Forge chimney. Note rotating jib, to right of chimney, looking south

On the east side of the forge is the chimney which passes upwards and through the roof. In its lower parts, for about 11 courses, the chimney is built of late handmade bullnose bricks of probable late 19th century date (Plate 13). Above this the chimney is of older, probably 18th century, handmade brick. As it rises the chimney twists to become square with the

To the east of the forge, set in to the floor, is a millstone. This, specifically its socket, may have functioned as a previous base for an anvil. Toward the southwestern corner of the room are a rotating jib (Plate 13) and a concrete block machinery base. On the rotating beam of the jib are the initials 'WM' and 'WMS'.

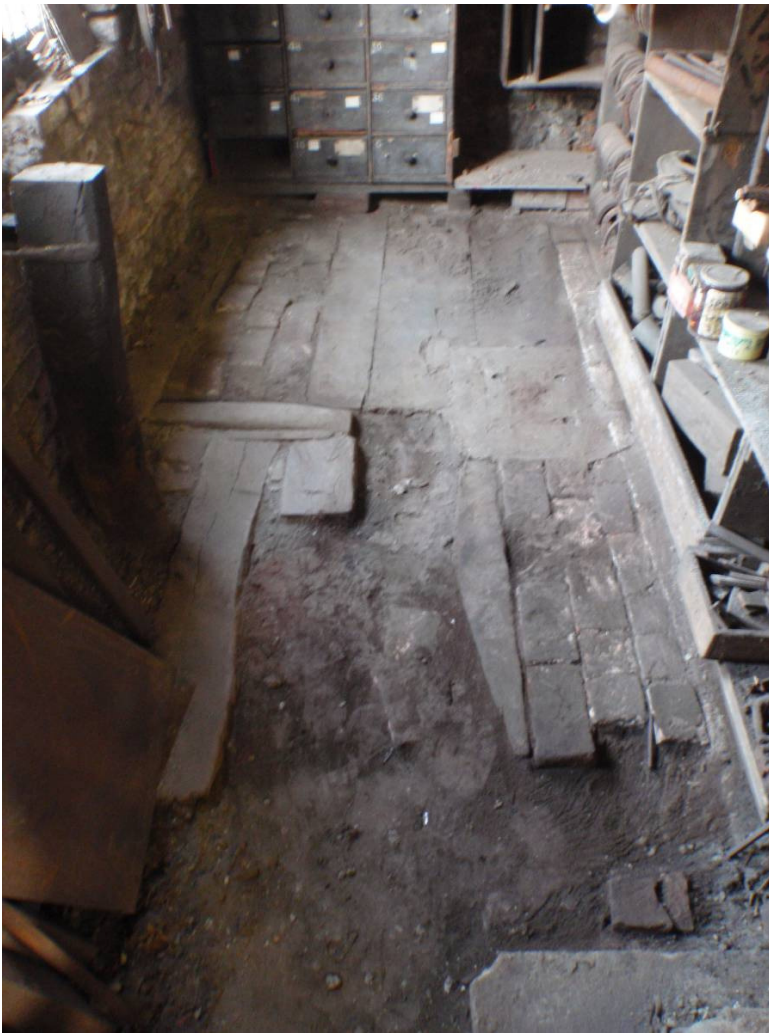
Plate 14 Smithy, northern part of main room, looking northeast

In its western part, the northern side of the room extends northwards beyond the remainder (Plate 14). In this section, within the north wall there is a straight join set about 1.5m above ground level, with the base of a chimney rising from this. In this part of the room the floor is a mixture of boards and late 19th century handmade bricks, with areas of exposed earth. On the east side there is also a concrete block machinery base, containing four cut-off screws that machinery would have been secured with (Plate 15). Removal of some of the floor boards during the survey revealed a quantity of late 18th and 19th century artefacts. Above this recessed section of the room is a raised platform for storage.

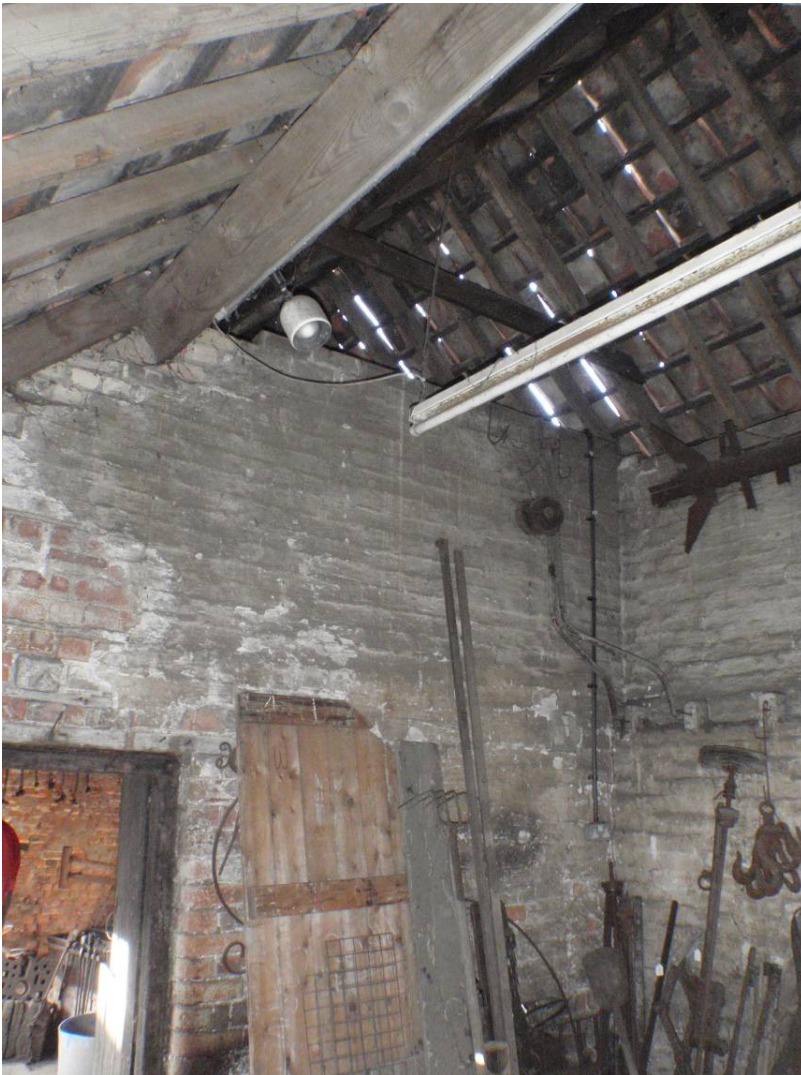
Plate 19 North wall of northern room, showing blocked window, looking north

The doorway provides access to the northern room, which has a floor of handmade brick. The north wall of this room is of probable 19th century handmade brick and contains a blocked window high towards the western end (Plate 19). At the eastern end of the wall is a 20th century machine-made brick pier which forms the north jamb of the double doors that form the east side of this room. The 20th century pier meets the north wall in a straight join.

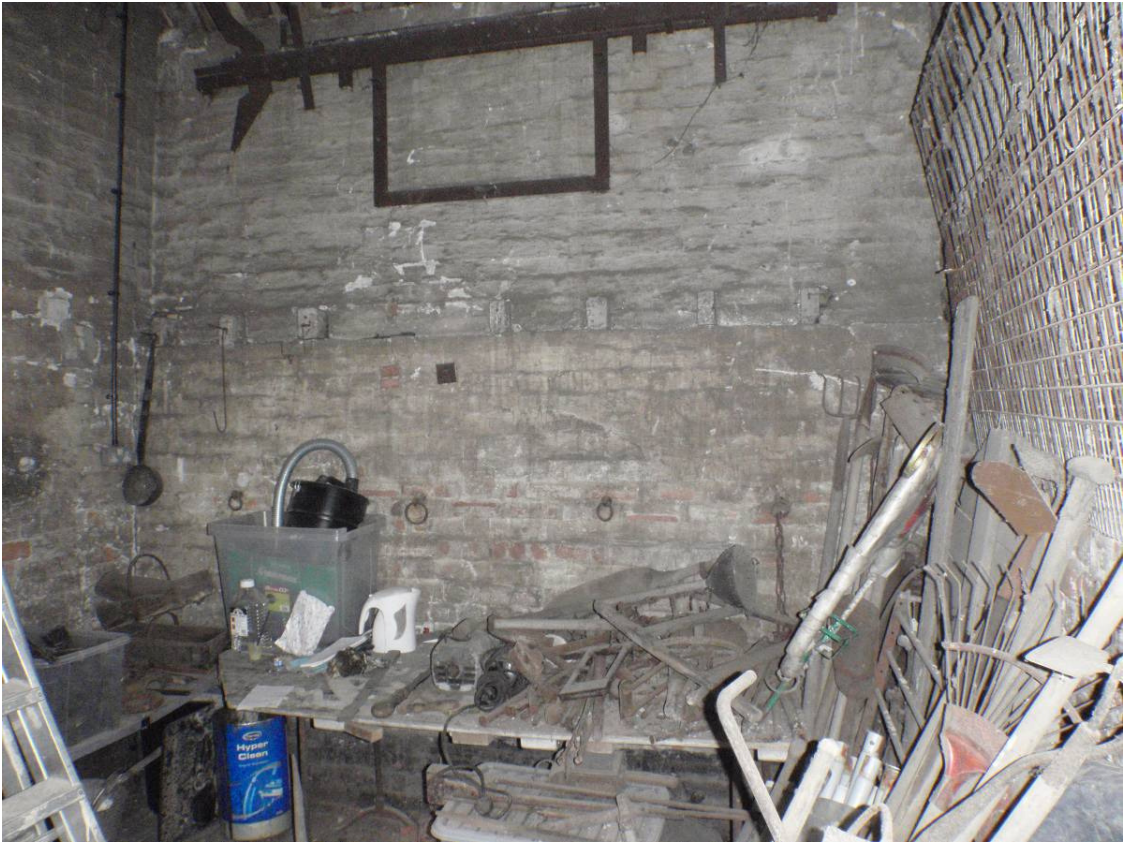
Plate 20 South wall of northern room, looking southwest

The south wall is in separate sections, split by the doorway to the main southern room. East of the door, and to the top of the doorway, the walling is of handmade 18th century, brick (Fig. 8). Above this level the walling is of mixed brick but includes late 20th century brick. To the west of the doorway the walling is of mid-late 19th century handmade brick, with bullnose bricks at the door jamb. The south wall terminates at the height of the purlin and does not go up to the ridge line (Plate 20).

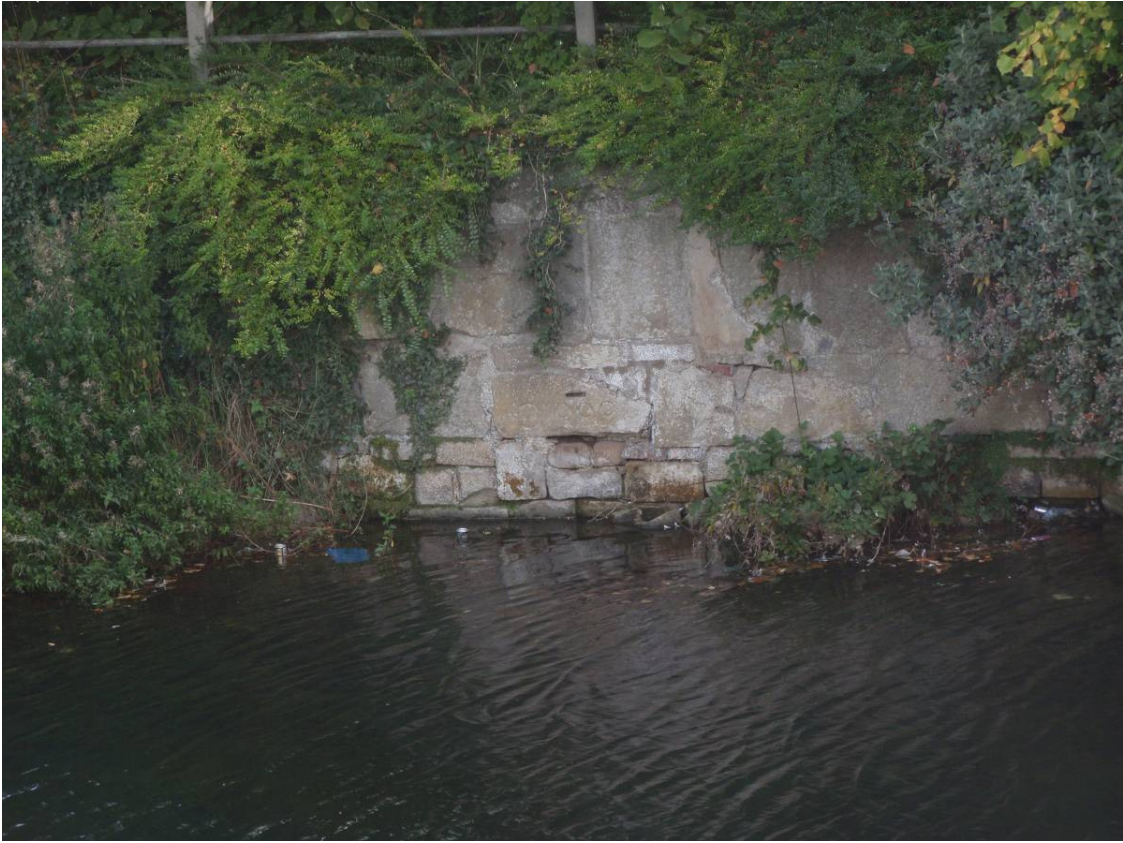
Plate 22 Section of wall adjacent to smithy building, looking south

Immediately alongside, to the south of, the smithy is a section of walling. This walling is constructed of handmade brick and stone and mostly butts against the smithy, although a part is cut into the base of the western elevation of the smithy (Plate 22). At its southern end, at the southern boundary of the smithy property, the walling appears to have a gap in it, though this area is much obscured by vegetation. However, this gap has the appearance of a drain outfall.

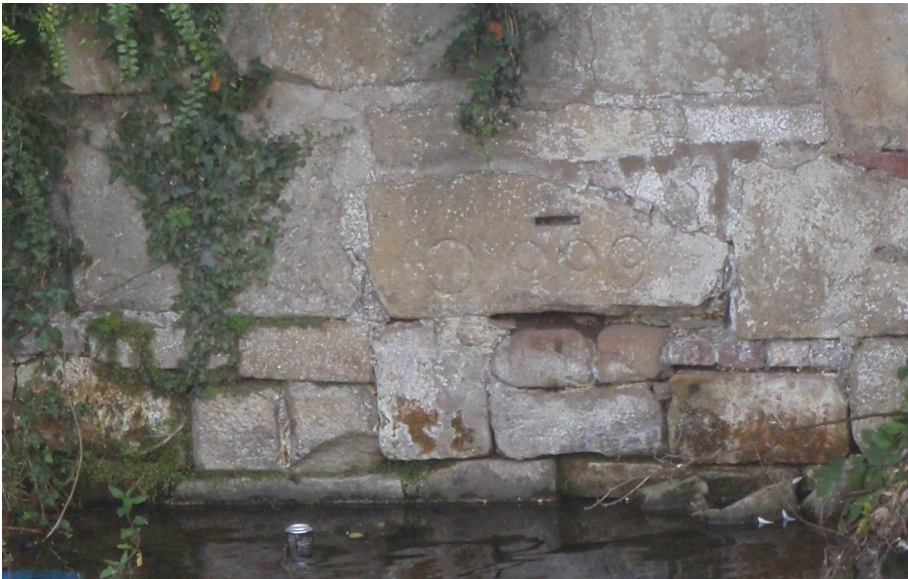
Plate 23 River wall, looking southeast

South of the vegetation the river wall is of limestone blocks, one of them marked with what appears to be circles (Plates 23, 24).
